## RUNWAY CONDITION REPORT 18 MARCH 2019

The Norfolk Island Aerodrome runway is the subject of this report. The photographs and descriptions below are as of 4pm local time on the 18 March 2019.

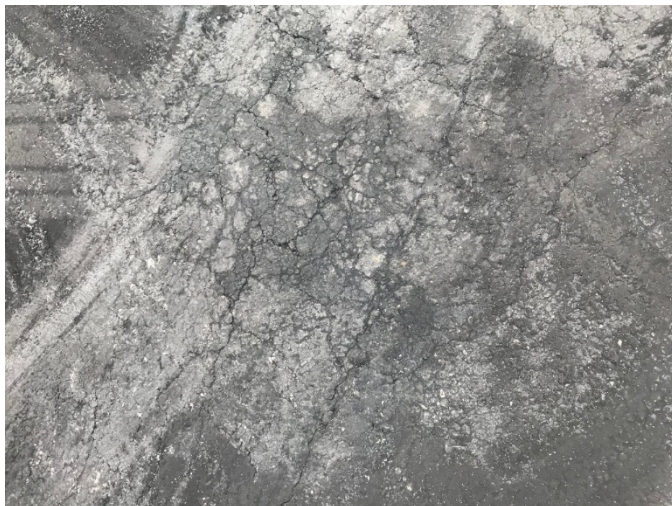
Image 1, above, apron bay

The taxiway and apron area in front of the terminal is in acute distress. The images numbered 1,2,3 below demonstrate the following:

A series of interconnecting cracks caused by fatigue failure of the hot mixed asphalt (HMA) surface under repeated traffic loading is called alligator or crocodile cracking, as shown in figure 1,2,3. High tensile strains at the bottom of the asphalt layer under a wheel load initiate fatigue cracks. The crack propagates to the surface as a series of parallel cracks, which get interconnected with repeated loading. Alligator cracking, which is predominant in the wheel paths, is considered to be a major structural distress that can lead to structural failure of the pavement.

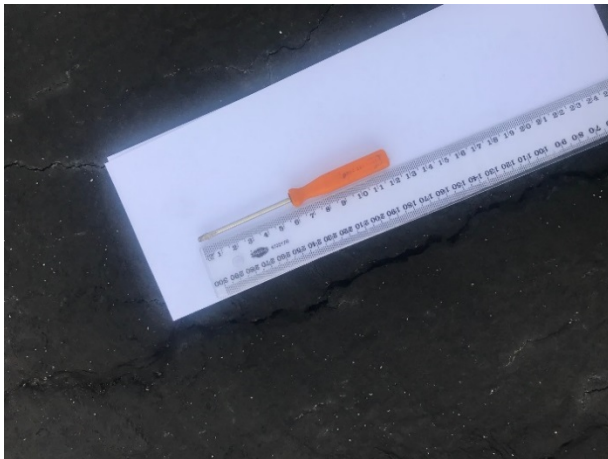
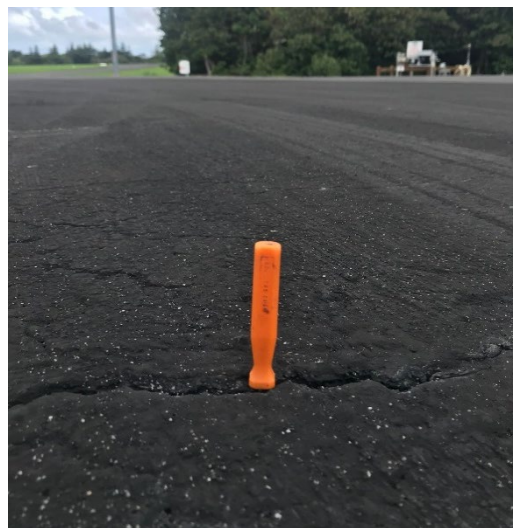
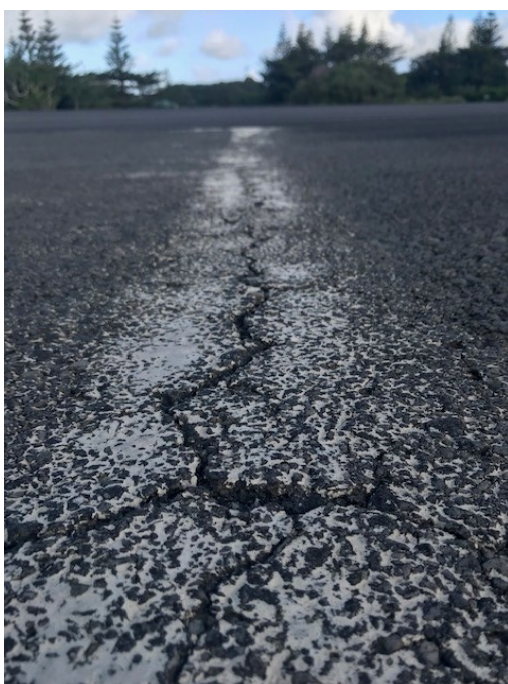
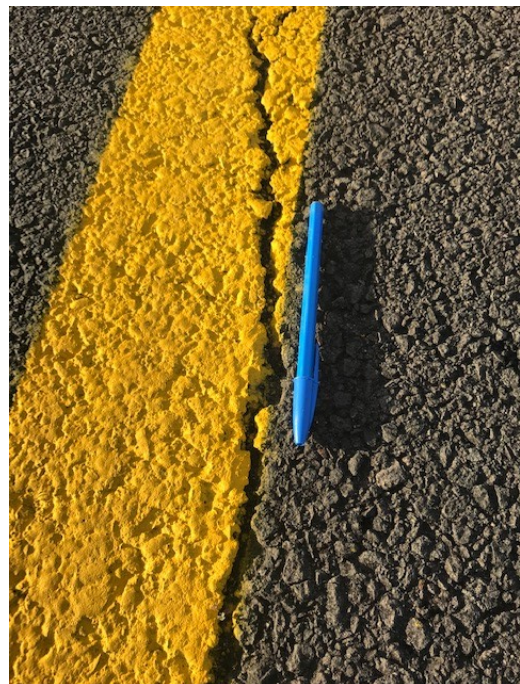
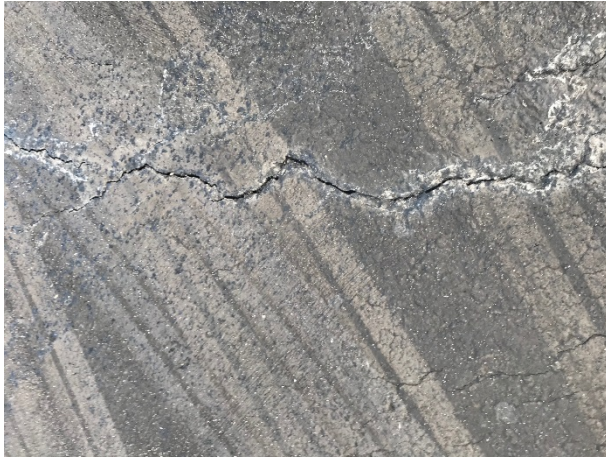
Longitudinal, transverse, and diagonal cracks divide the slab into two or three pieces and are generally caused by a combination of load repetitions, curling stresses, and shrinkage stresses. Medium- or high-severity cracks are usually working cracks and are considered major structural distresses.

These cracks represent a major problem and require constant monitoring. The Airport staff monitor these on a daily flight basis and address any issues as they occur

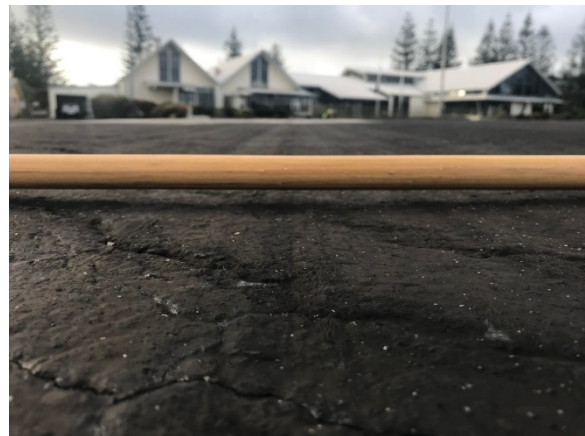
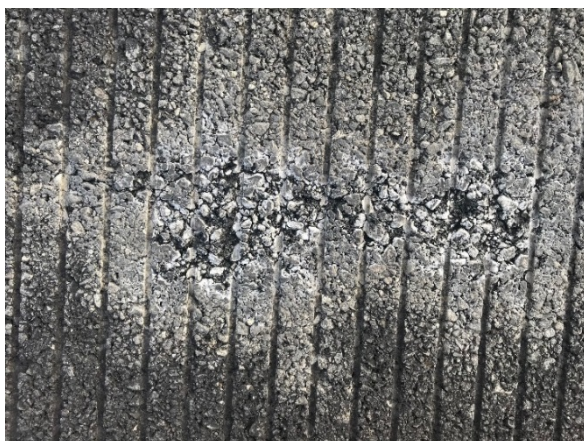
Pumping is the ejection of material by water through joints or cracks caused by the deflection of the slab under moving loads. As water is ejected, it carries particles of gravel, sand, clay, or silt, resulting in loss of pavement support. Pumping near joints indicates poor joint sealer and loss of support that will lead to cracking under repeated loads. Pumping can occur at cracks as well as joints and is classified as a functional distress.

Wearing away of the pavement surface caused by dislodging of aggregate particles and loss of asphalt binder leads to raveling and weathering. It indicates significant hardening of the asphalt binder and can cause severe foreign object debris (FOD) problems and leads to functional failure.

Longitudinal cracking along the joints on the main runway
